HUARMEY DRAINAGE PROJECT, CONCEPTUAL PHASE

Consultancy report to Ground Water International, Lima, Peru

Roland Oosterbaan, agricultural water management specialist
Lima, July 18, 2008

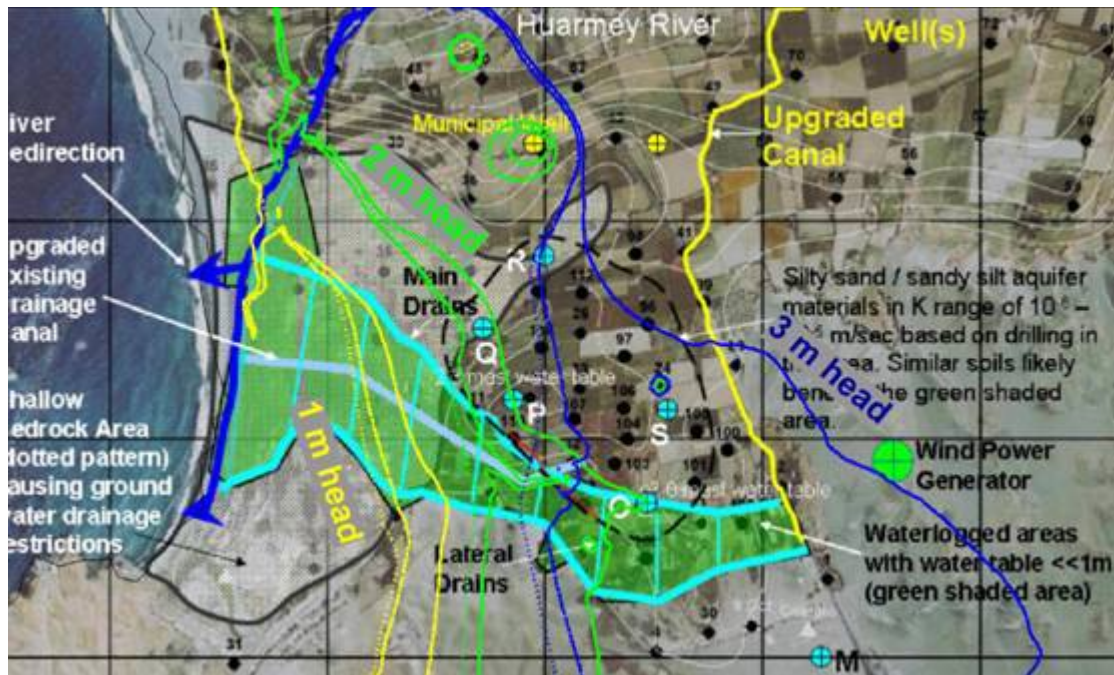
Figure 5. Simulation of groundwater levels after implementing a drainage system using FEFLOW

After inclusion of the lower permeability zone, groundwater drains were installed in Layers 1 through 3 of the model. The drains were assigned a drain conductance of 9 d^{-1} . The water table in the model was reduced by 1 m in the area of Well O. The results are shown in Figure 5.

The figure shows the steady state heads for the case without drains (dotted line), with only the main drain (dashed line) and with the entire drain system (three main drains and lateral drains (solid line)). The yellow head contours are the 1m contour, the green indicate 2 m, and the blue are the 3 m head contours.

In the absence of a topographic map, the groundwater contours cannot be translated into water table depths, needed to develop agricultural drainage criteria.

The simulated lowering of the groundwater levels has probably been obtained by maintaining a sufficiently deep water level in the main drains at their outlet. This would require the presence of pumping stations.

The simulated lowering of the groundwater contours needs to be tested under an increased supply of irrigation water when the lands are reclaimed.

The projected northern and southern border drains will probably not be required as the lateral drains can discharge into the existing central drain, unless a topographic map overrules this statement. The extension of the central drain to the east (along the eastern part of the northern border drain), however, will be necessary to provide an outlet to the eastern lateral drains if they are installed.

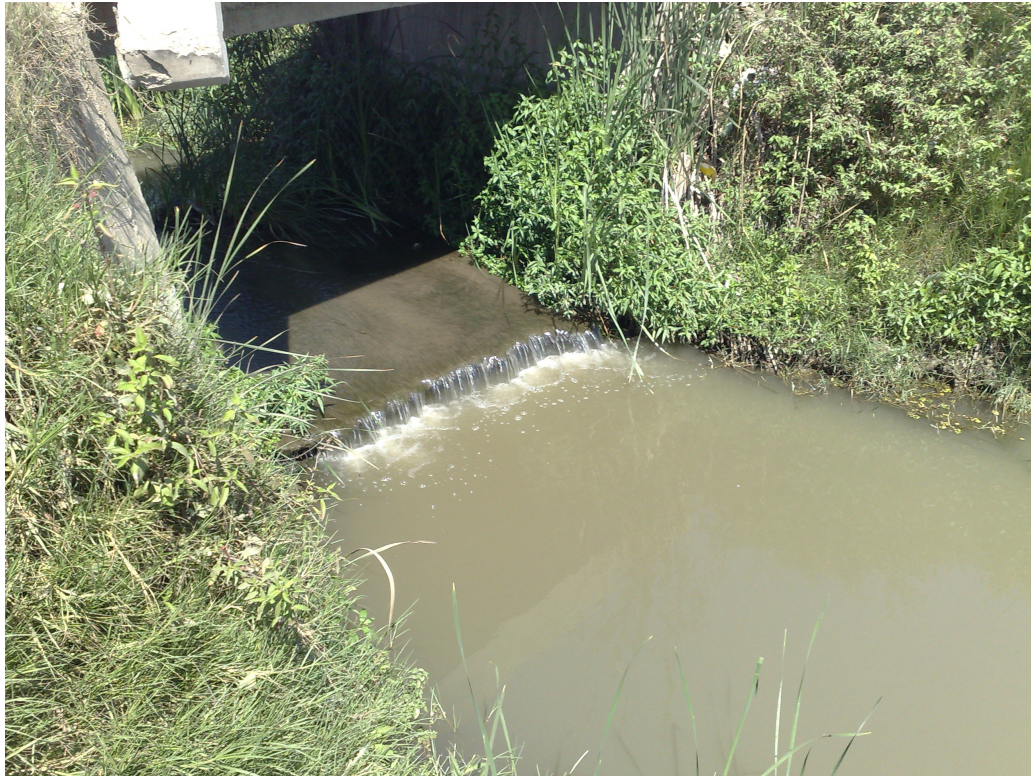
The cross-section of the central drain is now wide and deep. At the bridge, approximately halfway the drain, there is a small drop of a few decimeters (Photo 1) and the drain discharge was estimated at 10 l/s.

As the zone of influence of the drain upstream of the bridge is less than 50 ha, the drain discharge was more than 0.2 l/s per ha, which is almost 2 mm/day. At the time of the visit the area had probably not been irrigated for a period of more than a month, which indicates that the drain is intercepting upward seeping groundwater effectively. It remains to be seen how effective the drain will be when the lands are being irrigated.

The soil excavated from the central drain was dumped in heaps along the drain without any leveling and no attempt to create an even spoil bank to serve as an inspection road.

Photo 1. The recently cleaned central drain is discharging about 10 l/s.

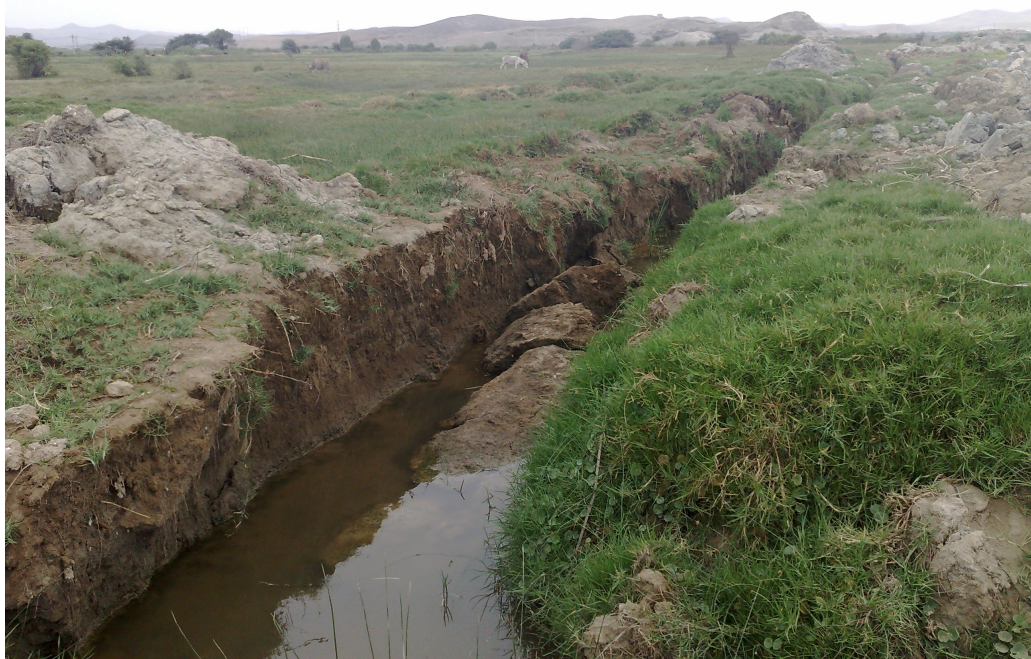
The lateral drain is narrow and has vertical walls that showed signs of caving in (Photo 2). Also here, the excavated earth was dumped in heaps and not spread. The discharge could not be assessed.

Photo 2. The recently excavated lateral drain collapses due to steep side slopes.

Excavated drains in waterlogged silty or fine sandy soils are usually very effective in lowering the water table, but they need gentle side slopes, say 3 (horizontal) : 1 (vertical), as these soils are unstable. In addition they need assured annual maintenance to restore the cross-section and remove the abundant vegetation.

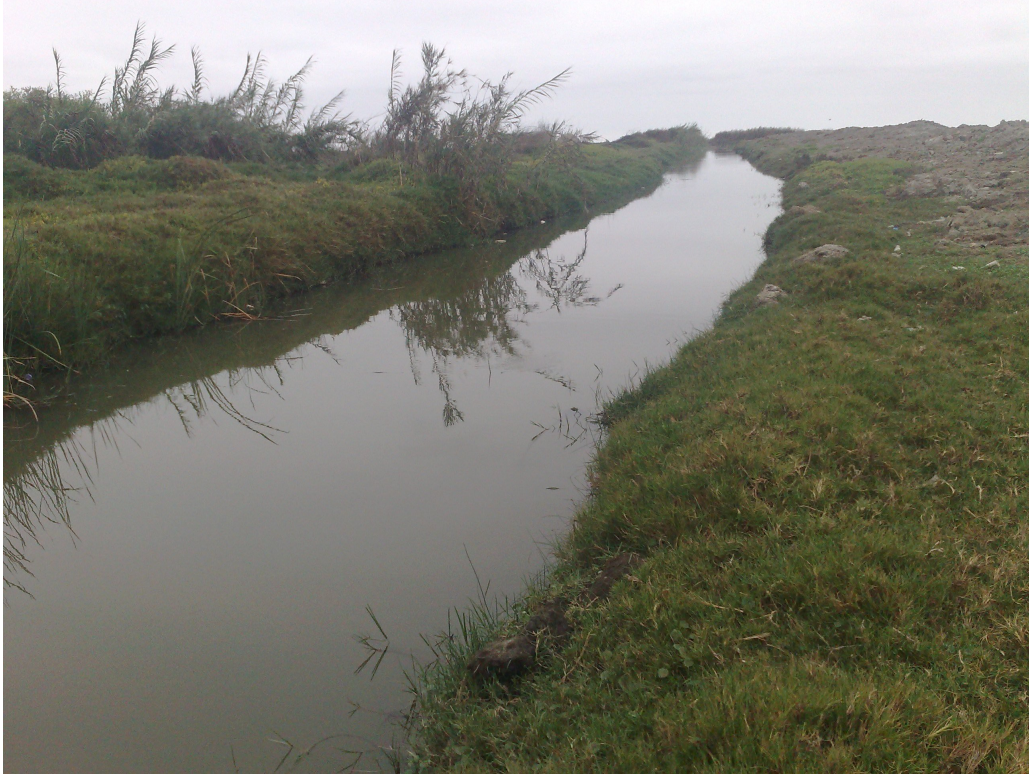
In the downstream reaches of the central drain the water level is too high to permit properly functioning lateral drains (Photo 3).

Photo 3. In the lower reaches of the central drain the water level is too high to permit properly functioning lateral drainage systems. A pumping station is required.

The central drain would have to be equipped with a *pumping station* to discharge the drainage water into the Huarmey river. Measures will have to be taken to *guarantee* the operation and maintenance of the pumping station.

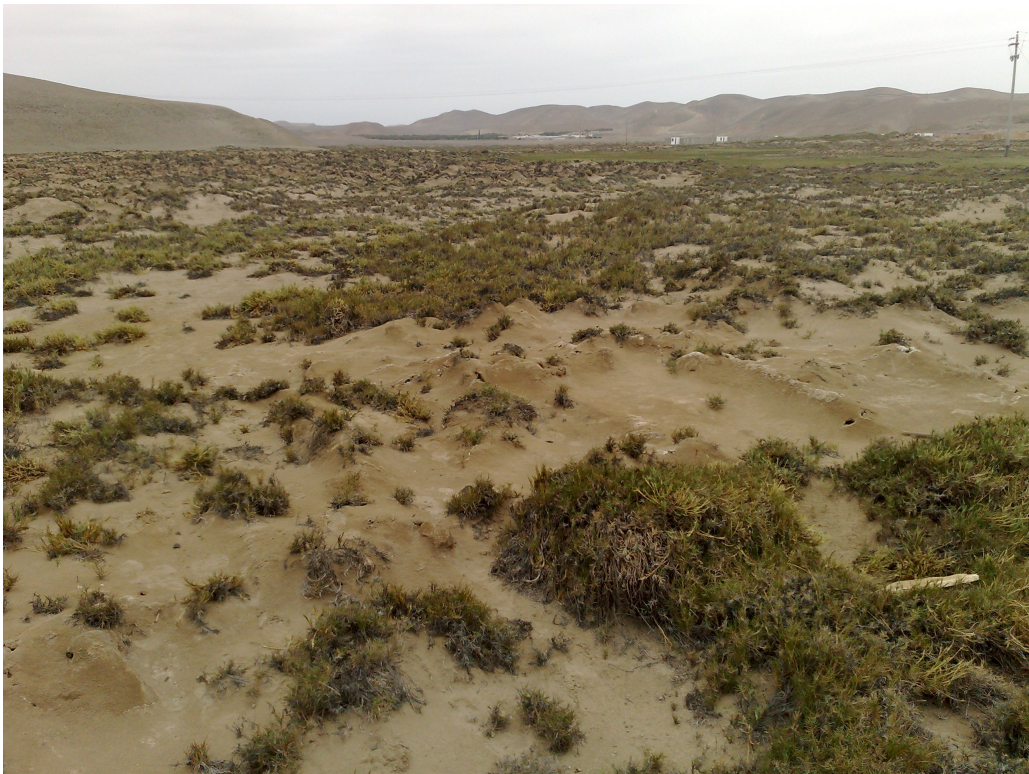
Subarea II consists of small dunes, stabilized by salt tolerant plants (Photo 4). It has never been cultivated. Like subarea I, it is far away from surface water resources and the availability of exploitable groundwater resources of reasonable quality for irrigation is doubtful.

Photo 4. Miniature dunes in subarea II

Most of what has been stated about the reclamation of subarea I also holds for subarea II. In addition it would be important to physiographically assess the small but numerous dune formations (Photo 1) to obtain more information on the feasibility of land levelling. Such information cannot be found in the soil map.

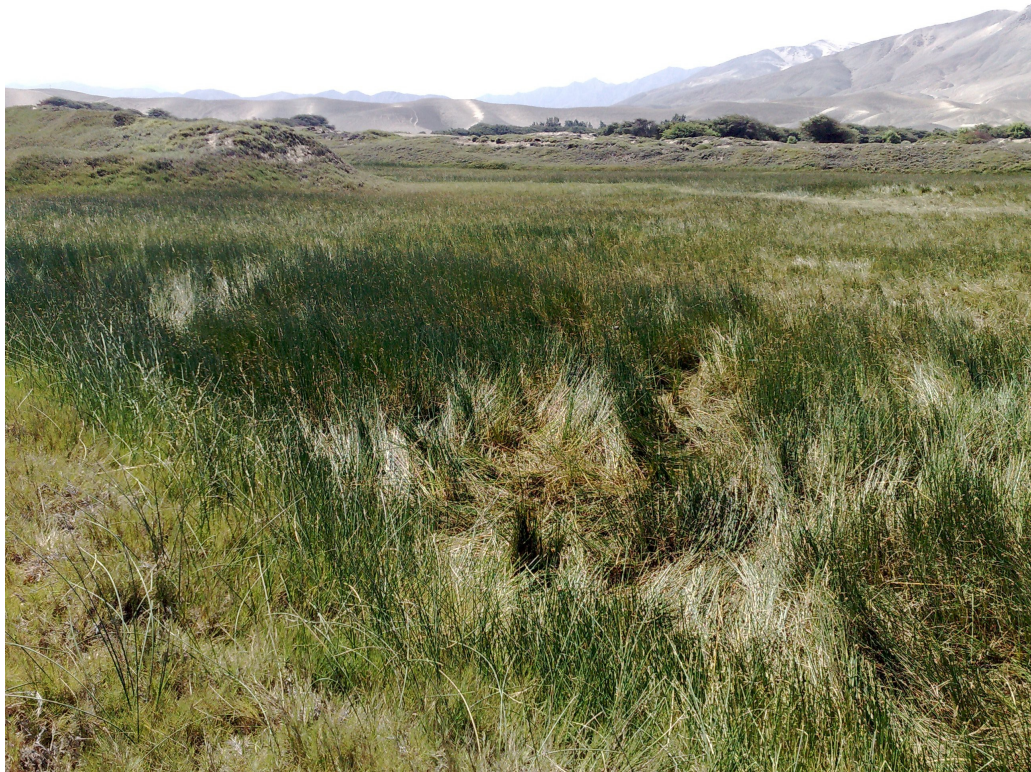
Subarea III shows patches of irrigated land intercalated with fallow lands (Photo 5) that show signs of agricultural use in the past. In this subarea, the farm of Victor has fields with maize and alfalfa to provide fodder for his dairy cattle (Photo 6). A considerable part of his land is fallow. The irrigation water is supplied by a canal that receives water derived from the Huarney river. The canal appears to be connected to an outlet for excess water. The crop stands are poor. There is a dug well on the farm for household purposes. Victor lives on the farm with his family and derives his main income from work elsewhere. The family experiences a mosquito problem.

Photo 5. Unused land in subarea III, waterlogged and saline.

Contrary to the previous subareas, it seems attractive to explore the possibility to perform subsurface drainage in subarea III by shallow tube wells at a density of say one well per property. Each landowner would then be responsible for maintenance and operation of the well.

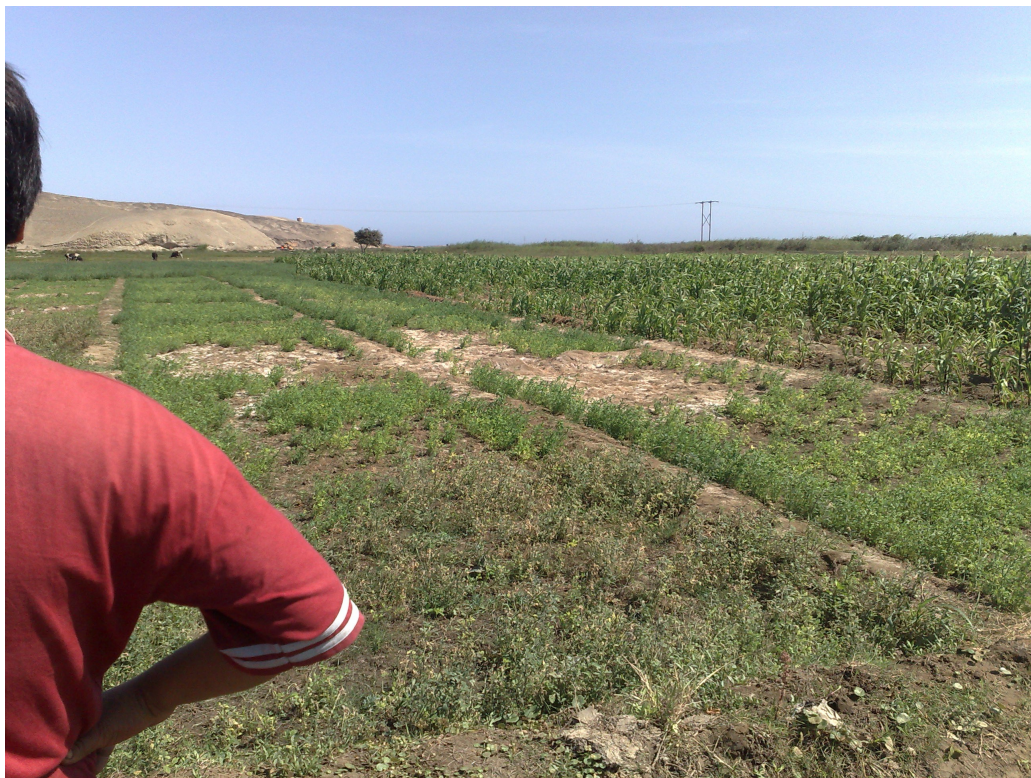
Photo 6. Stunted growth in the alfalfa field of farmer Victor in subarea III. The maize crop to the right, used as fodder, is also growing poorly.

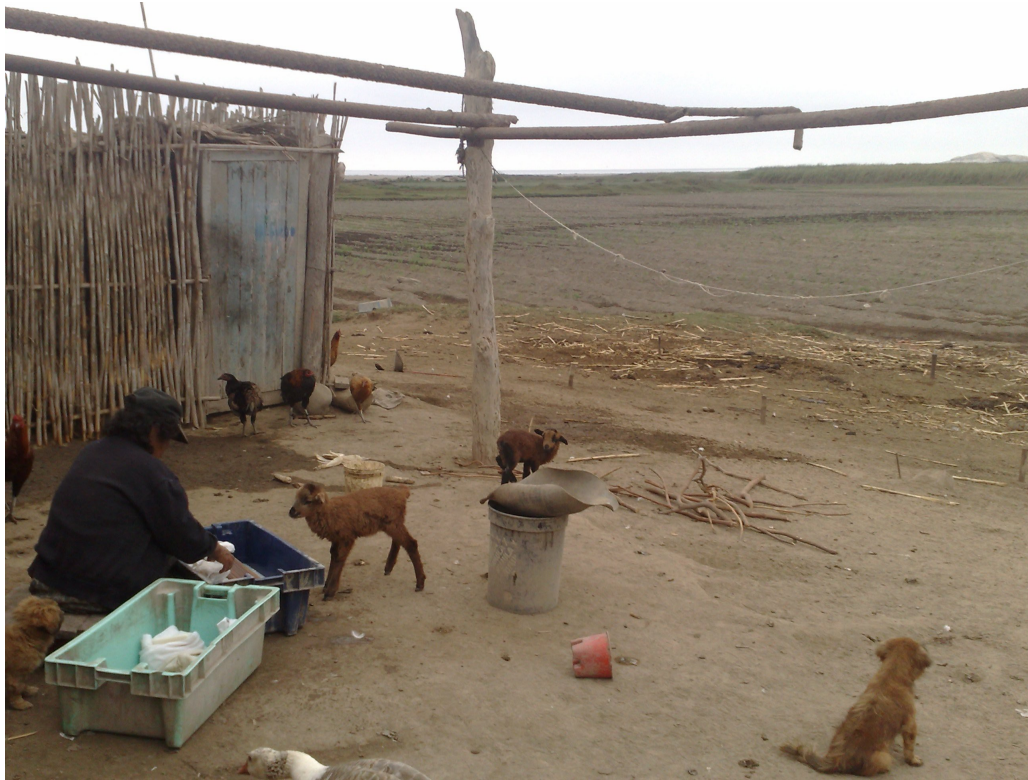
Subarea IV, like subarea III shows patches of irrigated intercalated with fallow land. Contrary to subarea III, the fallow land does not show signs of cultivation in the past. Two farmers were visited here, an elderly man and an elderly woman (Photo 7) who live there alone. They cultivate asparagus. The irrigation water is bought from a small association of farmers (at a cost of 70 soles/hr) who operate a tube well collectively. The woman obtained the land through the Reforma Agraria and she seems to continue to pay a contribution.

Photo 7. Female farmer in subarea IV. She manages the asparagus field in the background. Beyond that field, another field is seen, which is presently not cropped but it was cropped in the past.

If the subarea IV is to be reclaimed, it is recommended to excavate a number of lateral ditch drains that discharge into the central drain. The ditches would need to be approximately 1.5 m deep with gentle side slopes and spaced at about 50 m. The field drainage system will also help in controlling the mosquito population.
